Research Paper
PNW-RP-428
September 1990

Lumber Recovery From Dead Ponderosa Pine in the Colorado Front Range

Susan Willits, Richard O. Woodfin, Jr., and Thomas A. Snellgrove

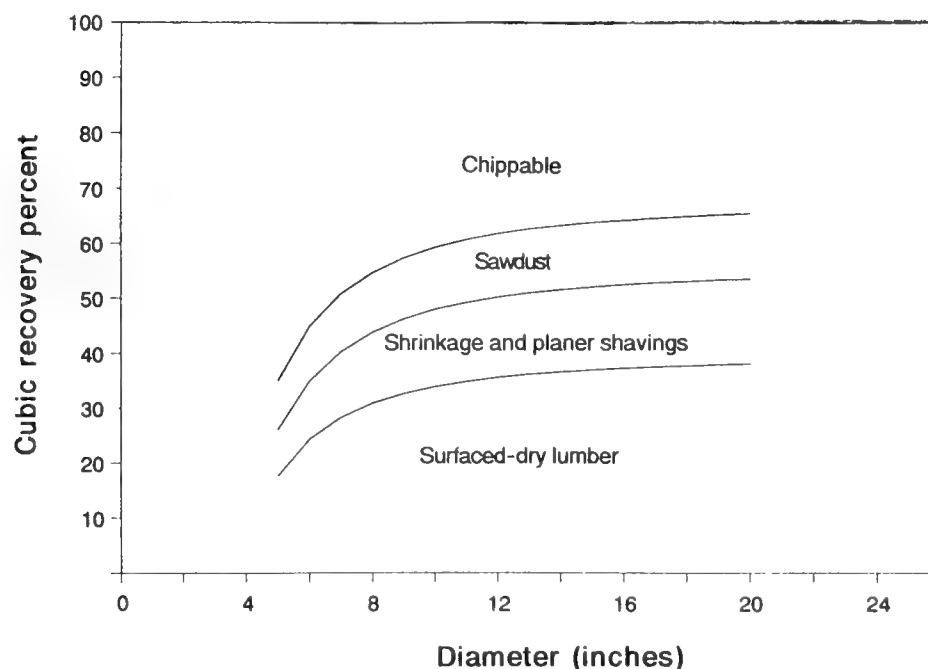
Figure 2—Relation of cubic volume recovery to small-end diameter for all logs combined. Cubic recovery percent of surfaced-dry lumber increases as log size increases, while shrinkage and planer shavings and sawdust remain constant over diameter. Equations and statistics are given in table 3.

Cubic recovery percent—The CR% of mill-length logs for surfaced-dry lumber, rough-green lumber, sawdust, and chips for the combined classes sums to 100 percent (fig. 2). The difference between surfaced-dry lumber and rough-green lumber is shrinkage and planer shavings. Chippable percentage is 100 minus rough-green lumber and sawdust. The CR% curve shows the expected pattern of low recovery for small logs, which increases sharply for intermediate size logs and levels off for larger logs. Mills are generally less efficient at converting small logs to lumber; therefore, a higher percentage of the log volume ends up as chips or hog fuel.

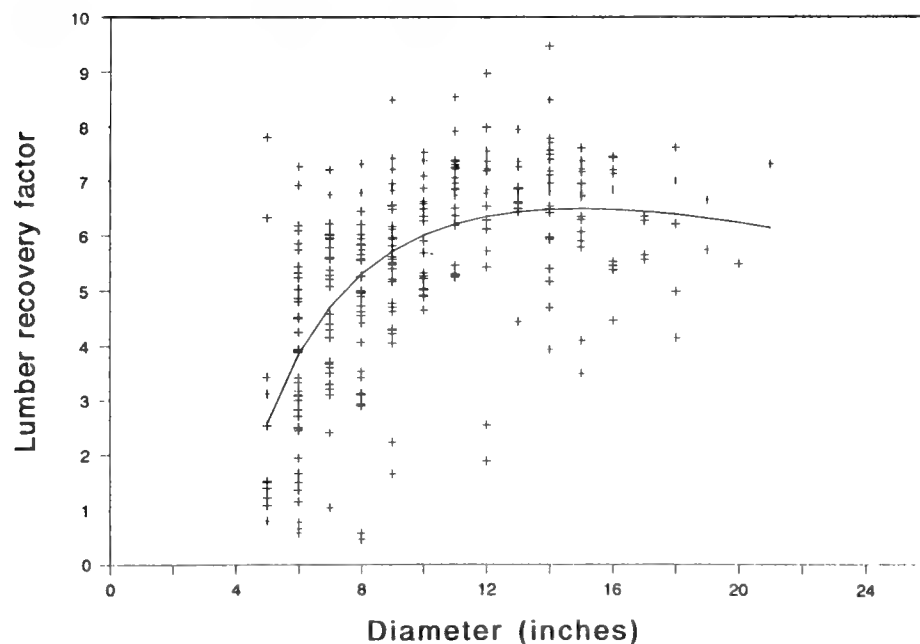
Figure 3—Estimated lumber recovery factor based on gross cubic volume, along with the data scatter, is shown for all logs combined. The relation of lumber recovery factor to log diameter is very similar to the relation of CR% of surfaced-dry lumber to log diameter. Equations and statistics are given in table 3.

Lumber recovery factor—Lumber recovery factor is the ratio of BF of lumber tally to CF of gross log volume. It follows a pattern similar to CR%, by increasing sharply for the small-diameter logs and leveling off for the larger logs (fig. 3). Rough-green lumber sizes, saw kerf, and product mix all influence LRF. Increased recovery (higher LRF) from a given log mix can be realized through improved log bucking accuracy, reduced saw kerf, reduced rough-green lumber target size, and sawing larger logs (Fahey and Martin 1974, Woodfin 1978).

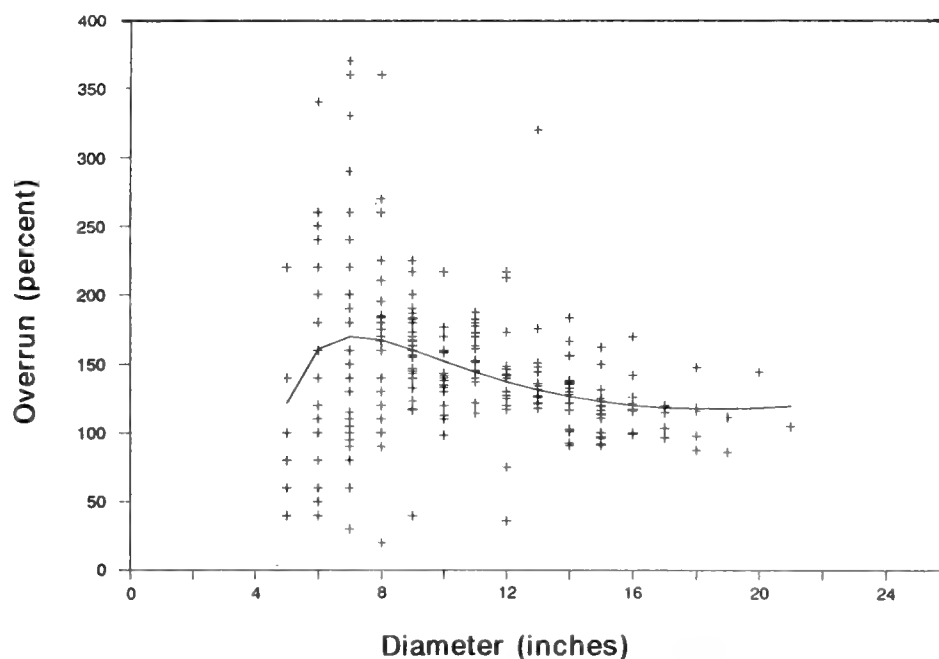
Figure 4—Overrun, based on net Scribner scale, is shown for live logs only. Unlike CR% and LRF, overrun peaks for 7-inch logs because of logs scale and taper and then decreases as log diameter increases. The variation in the data is greatest in the small-diameter logs because of variation in taper rates and manufacturing. Equations and statistics are given in table 3.

Overrun—Overrun is the common term used to describe the amount of lumber recovered that is in excess of the net log scale; it is expressed as a percentage of the net log scale. Unlike CR% and LRF, overrun peaks for 7-inch logs and then declines (fig. 4). This relation is typical of overrun and is caused by Scribner scale step functions and inaccuracies in estimating small-log volumes. Overrun is not shown for the dead classes of timber; the inaccuracy of the Scribner scaling rules when applied to logs from dead trees renders the net scale volume, and hence the overrun, meaningless. Snellgrove and Cahill (1980) discuss the problem in detail.

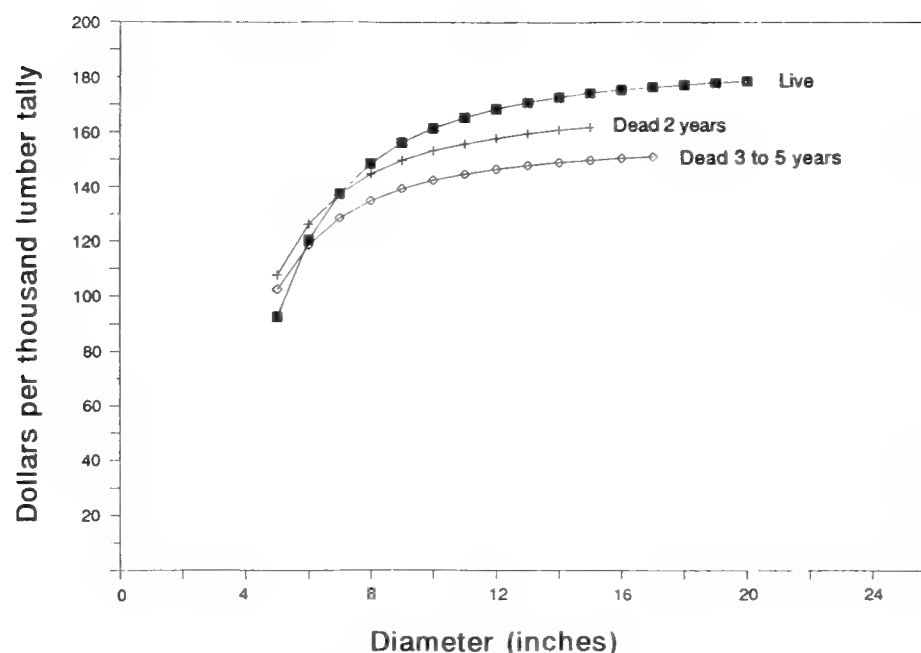
Figure 5—Dollars per thousand lumber tally (\$/MLT) was used to determine the final mortality classes. Although no practical differences were found in logs less than 8 inches in diameter, significant differences were found among the larger logs. Because the lumber was not priced by width, the differences in \$/MLT shown here are underestimating the real difference by 4 to 5 percent. Equations and statistics are given in table 3.

Dollars per thousand lumber tally—Estimates of \$/MLT were developed for the final three classes (fig. 5). Because of the variation in the data, no practical differences in value were found in logs less than 8 inches in diameter. Logs larger than 8 inches in diameter have about the same difference (roughly 6 percent) in value between class I and class II, and between class II and class III.

Because the lumber was priced by grade and not width, an additional source of value loss is not accounted for in figure 5. As discussed earlier, the checking in the dead timber resulted in a higher proportion of the lumber being manufactured into narrow boards. The price differential between a 1 by 4 and a 1 by 12 varies by lumber grade, but is estimated to be an increase of one-third to one-half in price. With a 12-percent increase in narrow boards for the class III sample, the decrease in value would be roughly 4 to 5 percent more than that shown in figure 5. The total loss in lumber value is therefore estimated to be 10 percent for class II and 17 percent for class III.

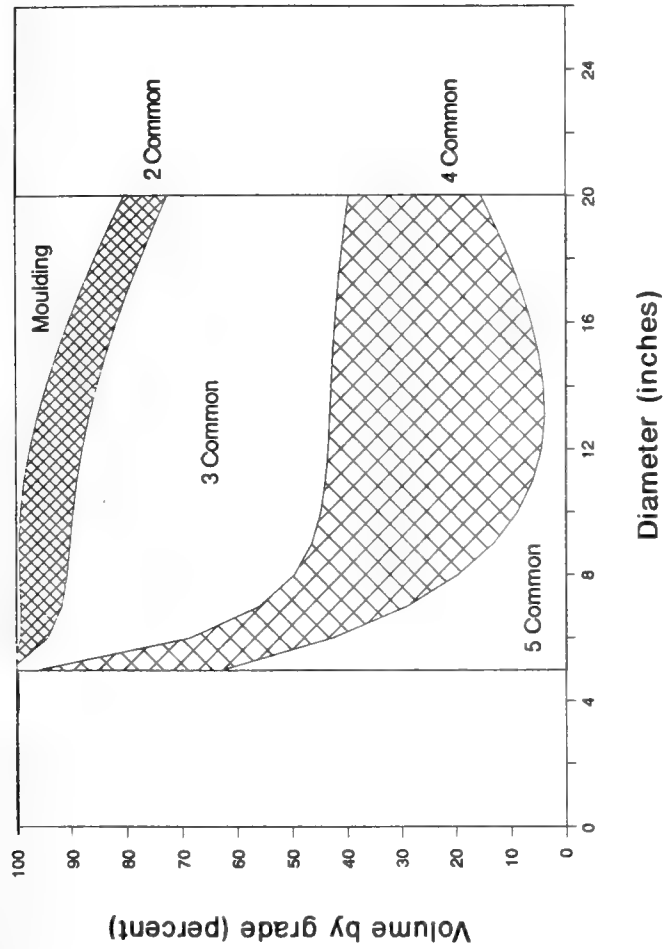
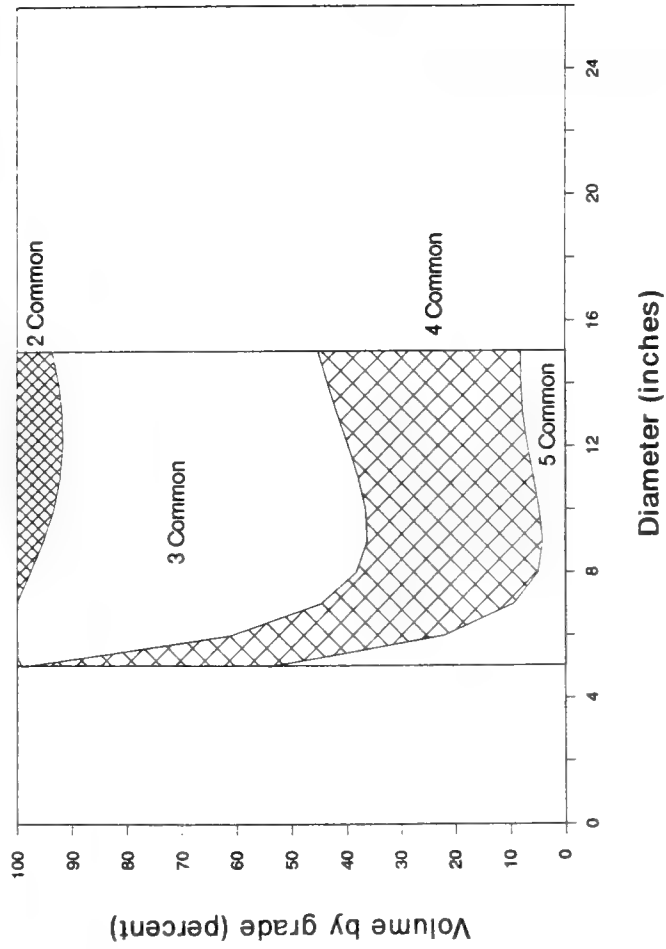
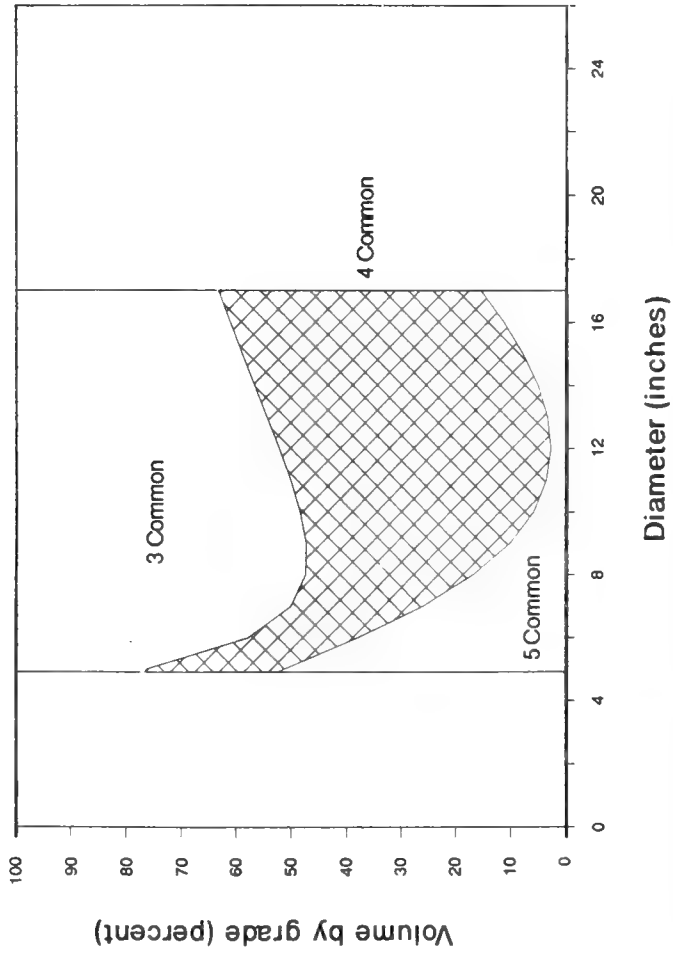
LIVE

DEAD 2 YEARS

DEAD 3 TO 5 YEARS

Figure 6—Cumulative percent volume by lumber grade for each of the final classes are shown. **A.** Moulding and Better lumber was produced only from the live sample. Because only a small portion of the mill's production was Moulding and Better, it was sold as 2 and Better Common. **B.** The percentage of 3 Common increased over the live sample because of blue stain. **C.** Because of heavy blue stain and checking, no 2 and Better Common was produced and there was a noticeable increase in 4 Common. Equations and statistics are given in table 3.

Lumber grade recovery—Recovery of lumber in each lumber grade can be used to help explain differences in \$/MLT among mortality classes. The relation between grade recovery and diameter is similar for all classes (fig 6). The percentage of 5 Common decreases with increasing diameter, and the percentage of 3 Common and 4 Common increases as diameter increases to about 8 inches and then remains fairly constant. The large percentage of 4 Common produced in this study was indicative of the type of trees sawn—small-diameter, limby, low-grade trees—and the manufacturing practices—air drying and poor stickering.

Lumber grade recovery was related not only to diameter but also to time since death. The highest grade of lumber, Moulding and Better, was produced only from the live sample. Class II logs produced less than 10 percent 2 and Better Common, and class III logs produced nothing better than 3 Common.

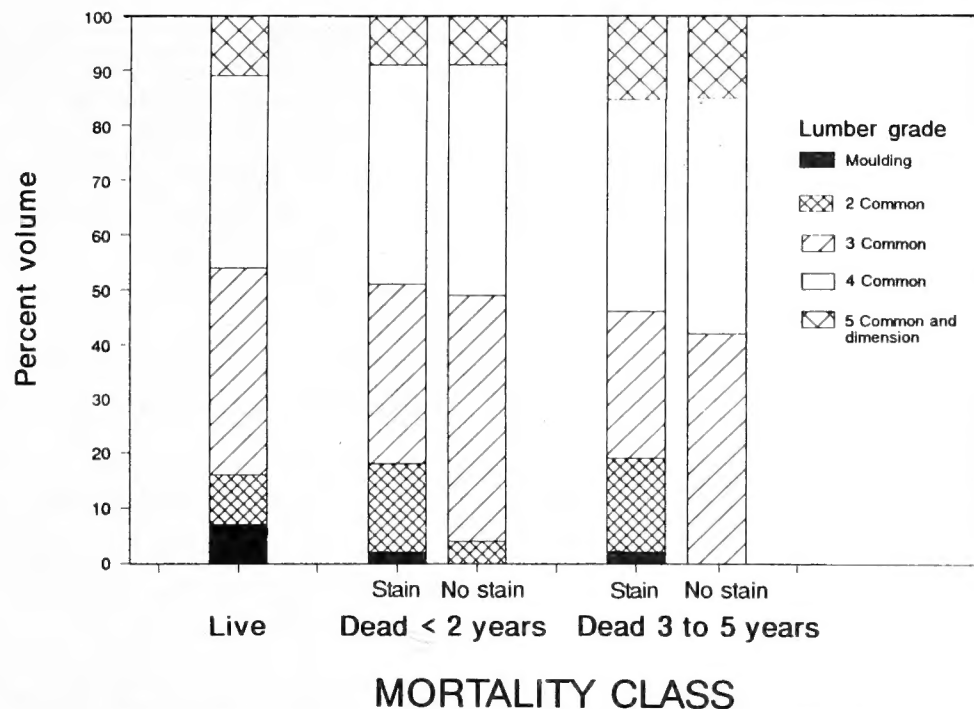
Figure 7—To evaluate the effects of blue stain on lumber grade, all the lumber was dual graded: once when stain was allowed in the boards and once when no stain was allowed on the board. There were no stained boards in the live sample; it is included for comparison only. The blue-stained boards from trees dead for 2 years dropped from 2 Common and Moulding and Better into 3 Common. The blue-stained boards from the trees dead from 3 to 5 years dropped into both 3 Common and 4 Common.

Figure 7 shows the average percentage volume by grade for boards graded with stain and ignoring stain for the final classes. Almost all the boards that were 2 and Better Common or Moulding and Better when stain was ignored were downgraded to 3 Common when stain was considered. There was also a slight increase in the percentage of 4 Common, but no change in the percentage of 5 Common. This shows that even in small-diameter low-grade ponderosa pine, stain caused a significant loss in lumber value and that most of the degrade occurred in the first year after death.
